Subject: AK Steel Dearborn Works – Civil Action No. 15-cv-11804
DJ # 90-5-2-1-10702

OPERATIONAL REVIEW REPORT

ELECTROSTATIC PRECIPITATOR

**AK Steel
Dearborn, Michigan**

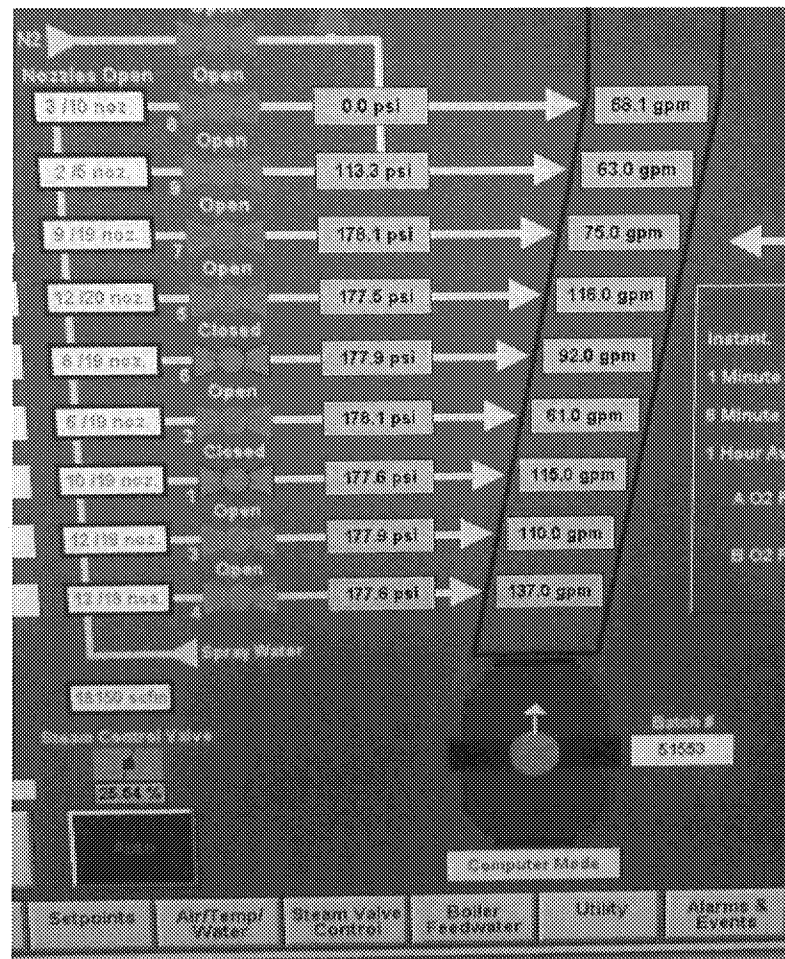
The actual condition of these nozzles is unknown. The listing on the left side of the following picture indicates that many nozzles are out of service. Based on the flows, I suspect this is correct. In watching the operation, it was noted that all the spray banks now operate on most heats. This is unusual. In previously observed conditions, spray banks 3 and 4 almost never turned on. These could be referred to be emergency nozzles, since they would operate only during a heat that was unusually hot. This allowed the system to accommodate problem heats. With all the nozzles in normal operation, the system has no reserve for a runaway heat. This would mean that a hot heat would cause a furnace trip.

Figure 1: B Vessel water sprays

As can be seen in Figure 1, the flow through each of the 1-7 banks of sprays are between 63 and 137 gpm. With all the nozzles in full operation, there would be approximately 150 gpm at each operating spray bank. Under normal conditions, 120 gpm per operating spray bank is common. By reducing the flow through each bank of nozzles, the system is simply forced to operate at a higher temperature in order to turn on successively more nozzle banks. This results in an average heat such as above operating with every bank in operation.

The problem with this type of operation is that any failure of one valve or any "hot" heat will simply trip the furnace and open the roof stack.

In the past, each of the spray banks 1 through 7 were operated at 120-150 gpm with new nozzles, and then once in operation, the boiler maintenance crews would locate the two nozzle banks that operated near equilibrium and adjust the flow of those two banks to provide smooth temperatures. Generally, nozzle banks 7 and 5 operate through the majority of every heat, and banks 6, 2, and 1 operate during the last half of each heat. Under normal conditions, banks 3 and 4 were not used except as backups. Some of the extended water flow may be attributable to higher blow rates than previously observed creating higher heat loads on the system.

- 6.1.1. Investigate the air flow system on the bank 8 sprays.
- 6.1.2. Maintain a flow rate of 120-150 gpm through spray banks 1-7.
